**Flood Control Project Maintenance
Levee Inspections**

Fall 2015 Levee Maintenance Deficiency Summary Report

Sacramento River Basin

Lake County Watershed Protection District

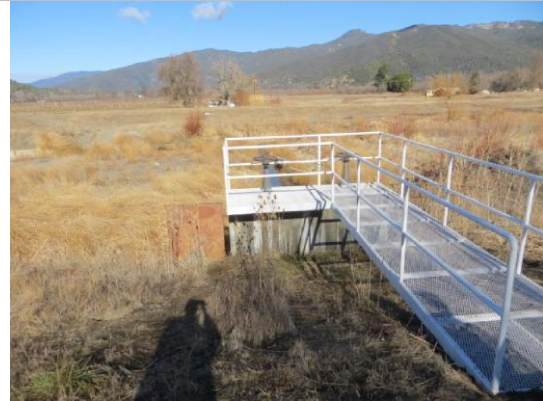
Photo 3 of 3 : UCIP_FA_2015_3417.jpg

Slide gate on steel walkway at WS toe.

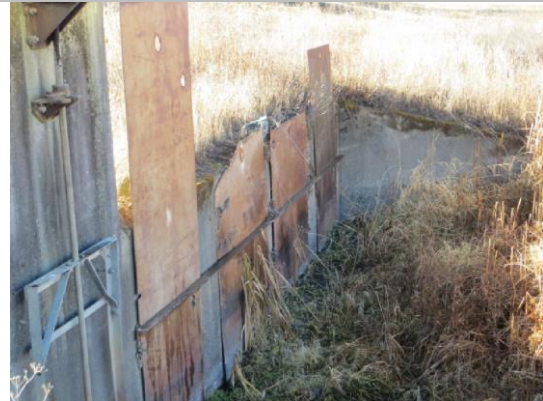
Photo 1 of 3 : UCIP_FA_2015_3412.jpg

LM Start	0.31	Rating **	M	Issue No.	13
LM End	0.31	Issue Type +	En	Location *	LS
Category	Supplemental			GPS Latitude/Longitude	
				Start	End
Item	DWR UCIP Field Study			39.177078 °	39.177078 °
				-122.898926 °	-122.898926 °
DWR ID					
Action/Comments					
Inspector Comments: FS_ID:26888					
DS_ID:21233					
EP_NO: 11507					
FS_HLM: 0.316					
Repair Type: Non-Urgent					
Crossing Status: Found					
UCIP Comments: Some sediment buildup at outlet on LS toe.					
FIELD_STRUCT_DESC: 3 of 6: 36-inch CM irrigation pipe through the					
levee, 12.0 feet below the crown. Concrete headwall on both ends.					
Steel slide gate plate blocks inlet on WS toe. Originally included in					
1961 O+M manual. Structure and pipes retained under ABO Permit No.					
11507 (1975).					
FS Date: 01/09/2014

Steel slide gate visible at concrete headwall on WS toe.

Inspector Comments: FS_ID:26888
 DS_ID:21233
 EP_NO: 11507
 FS_HLM: 0.316
 Repair Type: Non-Urgent
 Crossing Status: Found
 UCIP Comments: Some sediment buildup at outlet on LS toe.
 FIELD_STRUCT_DESC: 3 of 6: 36-inch CM irrigation pipe through the levee, 12.0 feet below the crown. Concrete headwall on both ends.
 Steel slide gate plate blocks inlet on WS toe. Originally included in 1961 O+M manual. Structure and pipes retained under ABO Permit No. 11507 (1975).
 FS Date: 01/09/2014

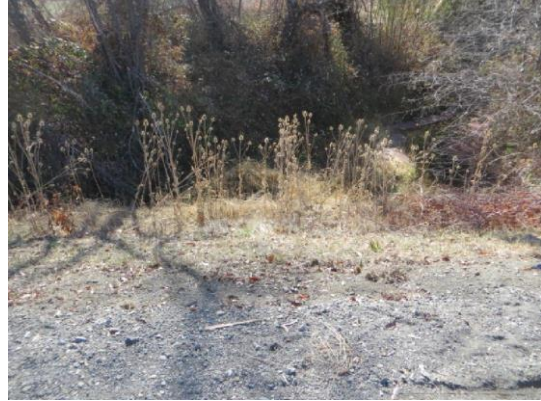
Photo 2 of 3 : UCIP_FA_2015_3413.jpg

Outlet visible at concrete headwall on LS toe.

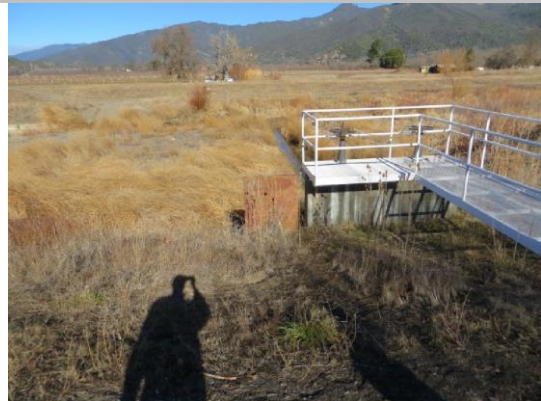
Photo 3 of 3 : UCIP_FA_2015_3414.jpg

Steel slide gate visible at concrete headwall on WS toe.

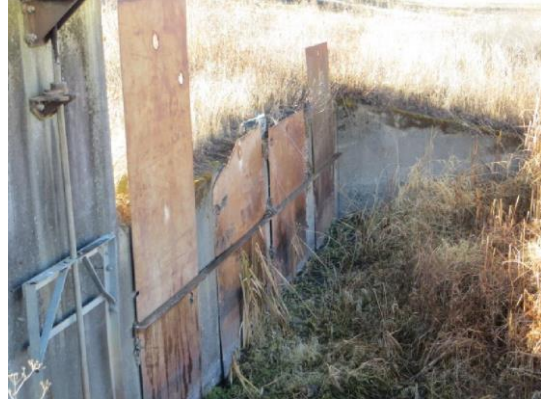
Photo 1 of 3 : UCIP_FA_2015_3381.jpg

LM Start	0.32	Rating **	M	Issue No.	14
LM End	0.32	Issue Type +	En	Location *	LS
Category	Supplemental			GPS Latitude/Longitude	
				Start	End
Item	DWR UCIP Field Study			39.177074 °	39.177074 °
				-122.898949 °	-122.898949 °
DWR ID					
Action/Comments					
Inspector Comments: FS_ID:26885					
DS_ID:21232					
EP_NO: 11507					
FS_HLM: 0.317					
Repair Type: Non-Urgent					
Crossing Status: Found

Steel plate slide gate visible at headwall on WS toe.

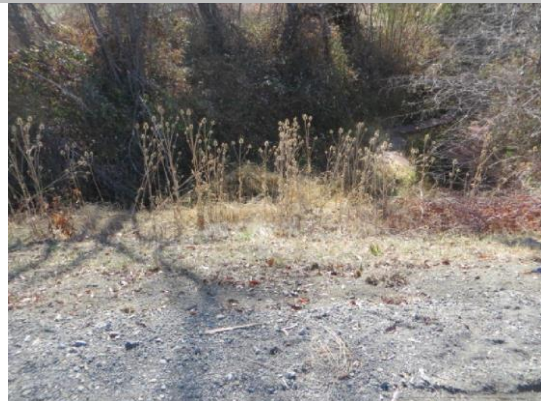
Photo 2 of 3 : UCIP_FA_2015_3410.jpg

Outlet visible at concrete headwall on LS toe.

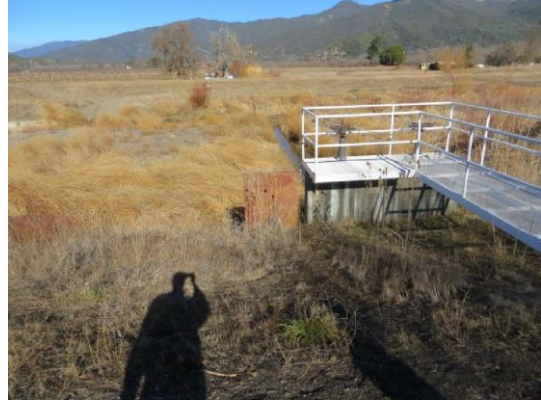
Photo 3 of 3 : UCIP_FA_2015_3411.jpg

Steel plate slide gate visible at headwall on WS toe.

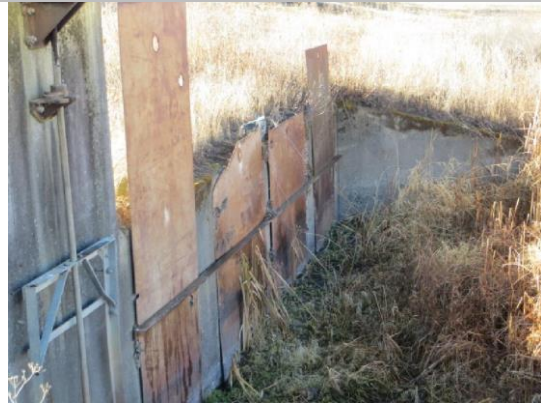
Photo 1 of 3 : UCIP_FA_2015_3378.jpg

LM Start	0.32	Rating **	M	Issue No.	15
LM End	0.32	Issue Type +	En	Location *	LS
Category	Supplemental			GPS Latitude/Longitude	
				Start	End
Item	DWR UCIP Field Study			39.177070 °	39.177070 °
				-122.898967 °	-122.898967 °
DWR ID					
Action/Comments					
Inspector Comments: FS_ID:26883					
DS_ID:21231					
EP_NO: 11507					
FS_HLM: 0.318					
Repair Type: Non-Urgent					
Crossing Status: Found					
UCIP Comments: Some sediment buildup on LS toe.					
FIELD_STRUCT_DESC: 5 of 6: 36-inch CM irrigation pipe through the					
levee, 12.0 feet below the crown. Concrete headwall on both ends					
[Clover Creek Diversion Structure] . Steel slide gate blocks inlet on WS					
toe. Originally included in 1961 O+M manual. Structure and pipes					
retained under ABO Permit No. 11507 (1975).					
FS Date: 01/09/2014

Metal slide gate visible at concrete headwall on WS toe.

Inspector Comments: FS_ID:26883
 DS_ID:21231
 EP_NO: 11507
 FS_HLM: 0.318
 Repair Type: Non-Urgent
 Crossing Status: Found
 UCIP Comments: Some sediment buildup on LS toe.
 FIELD_STRUCT_DESC: 5 of 6: 36-inch CM irrigation pipe through the levee, 12.0 feet below the crown. Concrete headwall on both ends [Clover Creek Diversion Structure] . Steel slide gate blocks inlet on WS toe. Originally included in 1961 O+M manual. Structure and pipes retained under ABO Permit No. 11507 (1975).
 FS Date: 01/09/2014

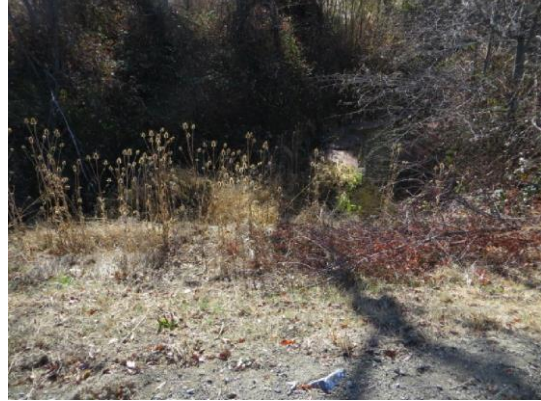
Photo 2 of 3 : UCIP_FA_2015_3379.jpg

Pipe visible at concrete headwall on LS toe.

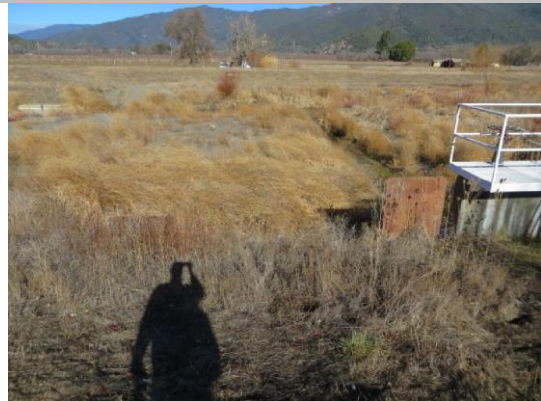
Photo 3 of 3 : UCIP_FA_2015_3380.jpg

Metal slide gate visible at concrete headwall on WS toe.

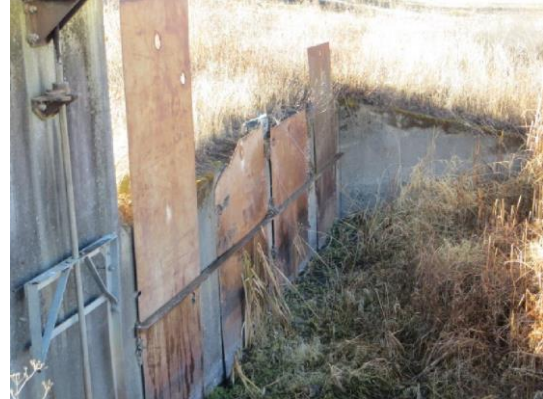
Photo 1 of 3 : UCIP_FA_2015_3375.jpg

Steel slide gate visible at headwall on WS toe.

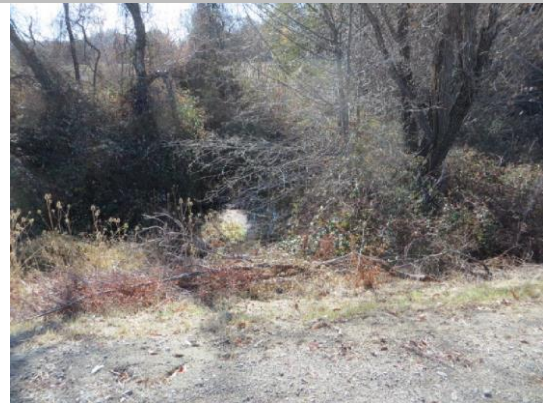
Photo 2 of 3 : UCIP_FA_2015_3376.jpg

Concrete headwall on LS toe.

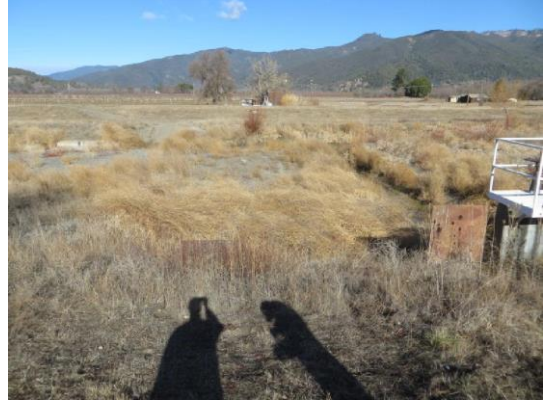
Photo 3 of 3 : UCIP_FA_2015_3377.jpg

Steel slide gate visible at headwall on WS toe.

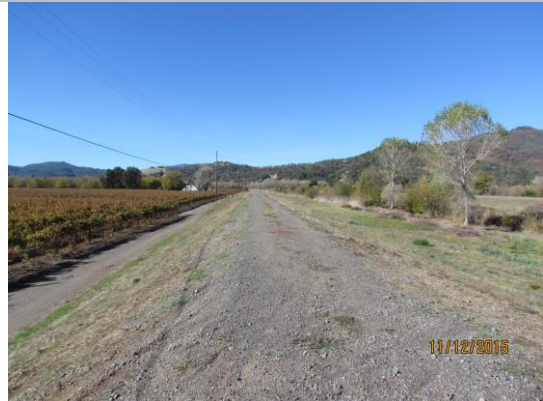
Photo 1 of 1 : FA_2015_NA0009_7_10_20151112_00003.jpg

LM Start	0.56	Rating **	A	Issue No.	10
LM End	0.56	Issue Type +	Ma	Location *	LS
Category	Earthen Levee			GPS Latitude/Longitude	
				Start	End
Item	Vegetation			39.175722 °	39.175722 °
				-122.903070 °	-122.903070 °
DWR ID	DWR_NA0009_05_f_2015_10				
Action/Comments					
Control annual grass and weeds on the levee slopes and easements. Inspector Comments: Lake Co. mowed both slopes.

View of acceptable vegetation on both slopes.
